# Using thermal imaging to troubleshoot motors and drives

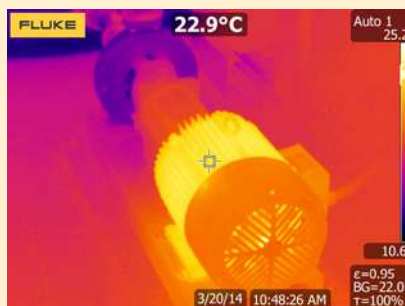
**Combo:** This heat pattern indicates an operational motor.
